Item 6 - Swansea Mews Udpate TCHC Public Board Meeting - June 28, 2022 Report#: TCHC:2022-42 **Attachment 1**

Engineering Report
Presented at the Swansea Mews Town Hall Meeting
June 14, 2022

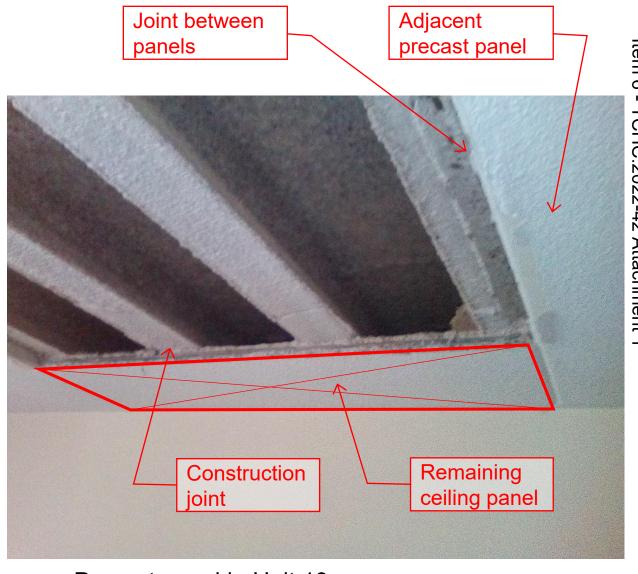
Precast panel in Unit 19

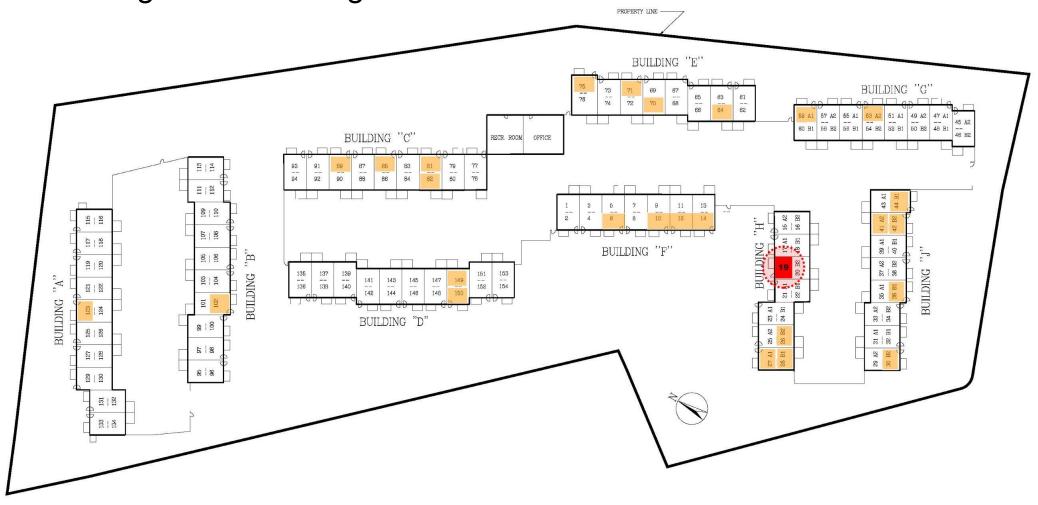
Electromagnetic Scanning Plan

27 (17.5%) of units scanned (or known)

5 / 378 (1.3%) of panels scanned (or known) exhibited detachment

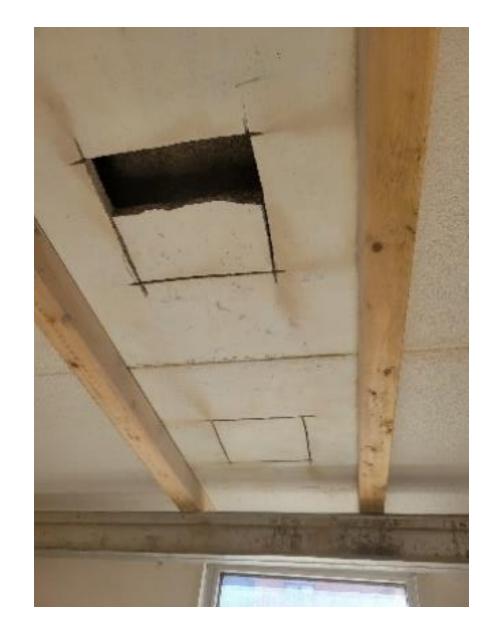
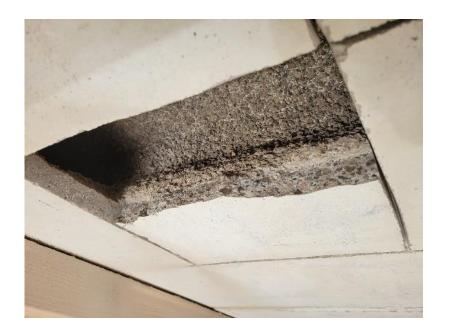
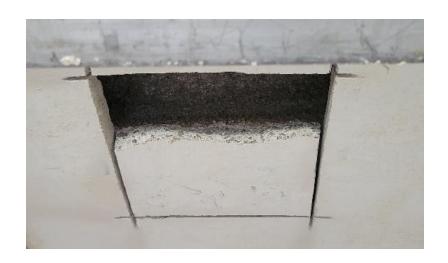
Examples of passing tests – underside of panel stays attached at "web"

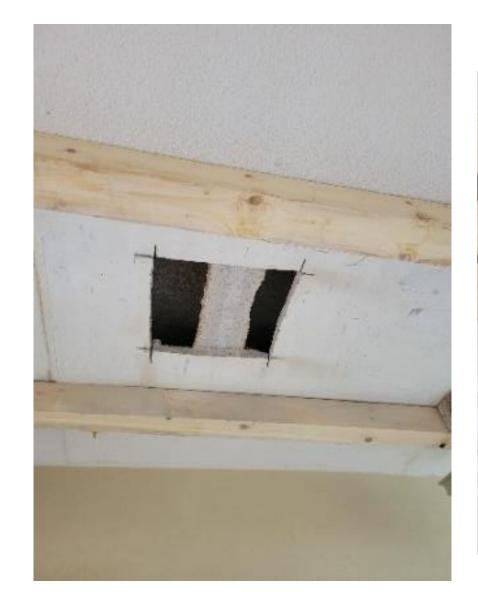
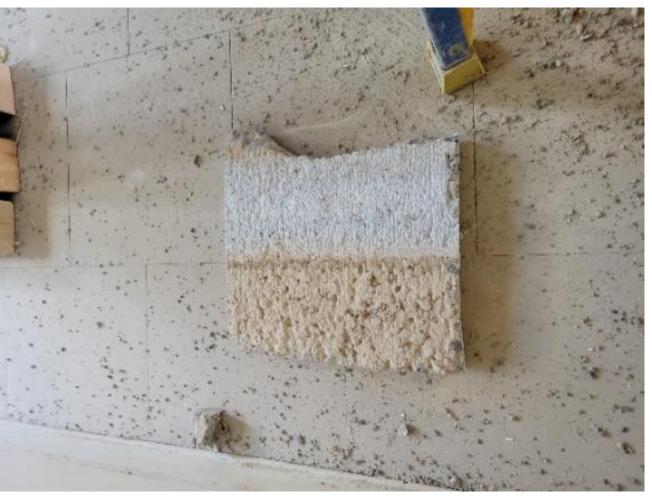
Example of failed test - panel failed clean separation occurred between underside of web and bottom of panel.

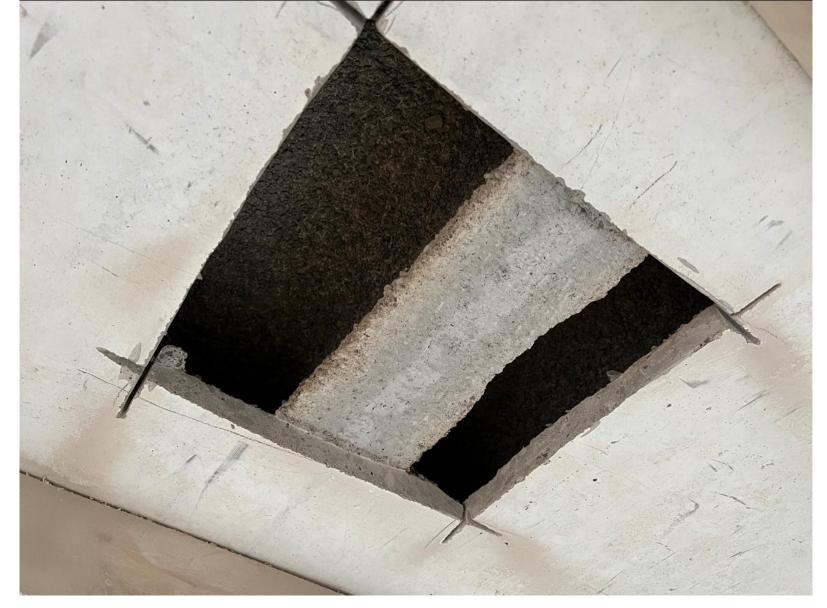
Destructive testing of the slab soffit (ceiling) – test shows a clear pour joint between the stems (main structure of the floor slab) and the soffit panel. Photo also illustrates that the concrete soffit is not reinforced (no bars or wire mesh visible at the cut lifes) nor is there any physical connection to the stem.

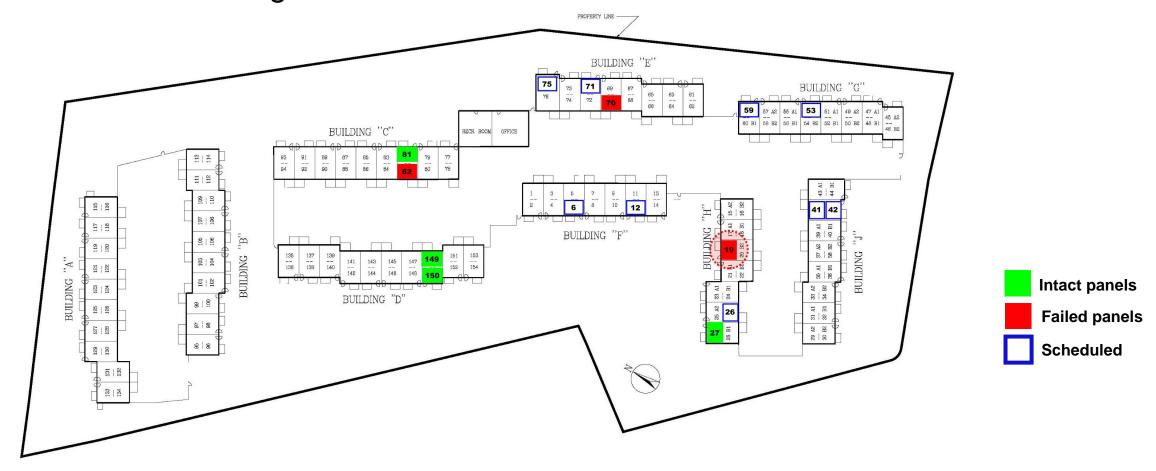
Destructive Testing Plan

3/14 (21%) of panels tested (or known) exhibited detachment

Based on these results, <u>every</u> panel in <u>every</u> unit must be tested in order to ensure safety of the tenants.
