Item 2D – Change Order: Additional Compliance Measures for Constructor Role and Unforeseen Conditions to the Envelope Repairs and Structural Rehabilitation Project at Mornelle Ellsemere
TCHC February 26, 2021 Board Meeting
Report #: TCHC:2021-02

ATTACHMENT 1 – SITE PHOTOS

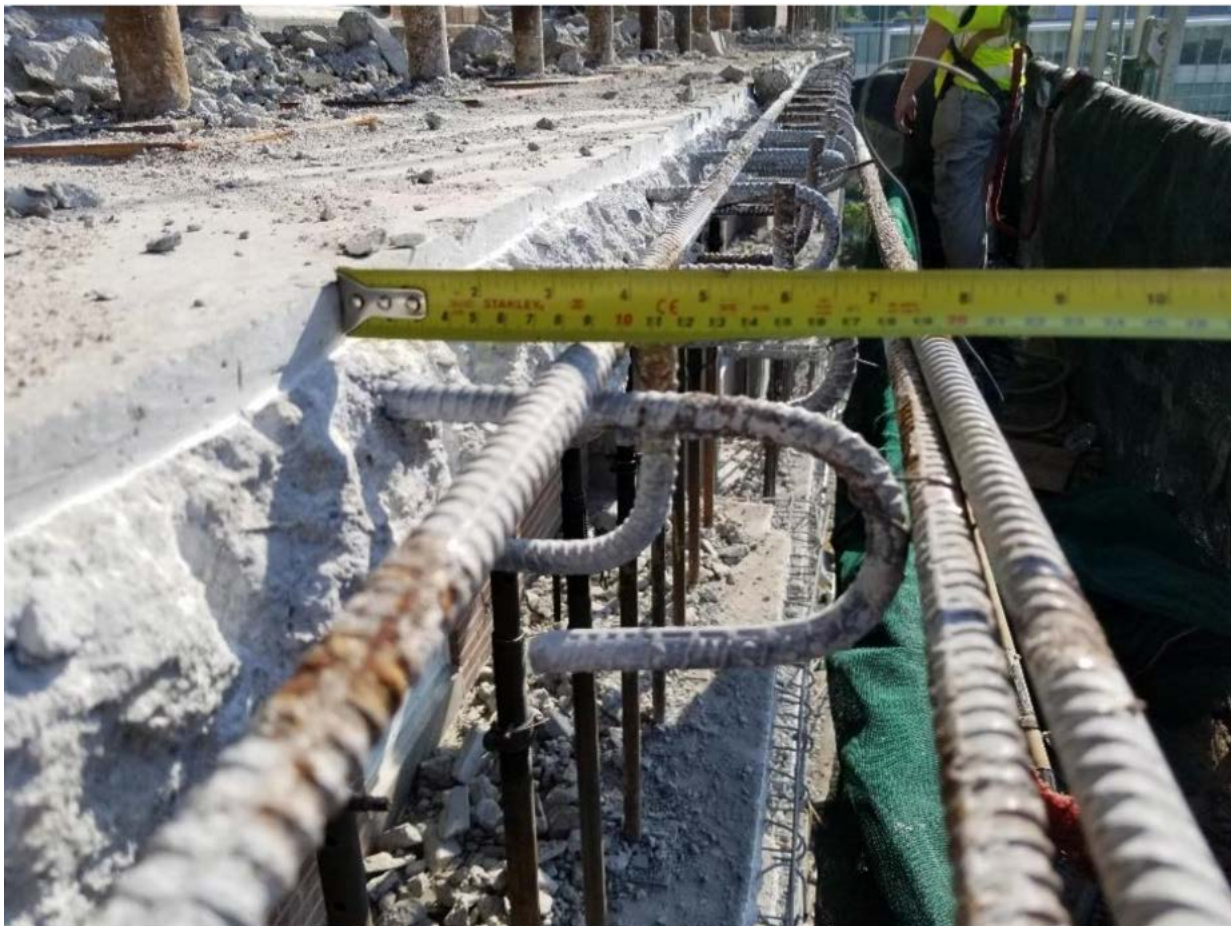
Image 1: Example of the current conditions of the structural reinforcement at the balcony slabs. Once uncovered, it was revealed that portions of the steel reinforcement required replacement, as well as a coating to prevent continued deterioration and rusting.

Reason for change – Unforeseen site condition

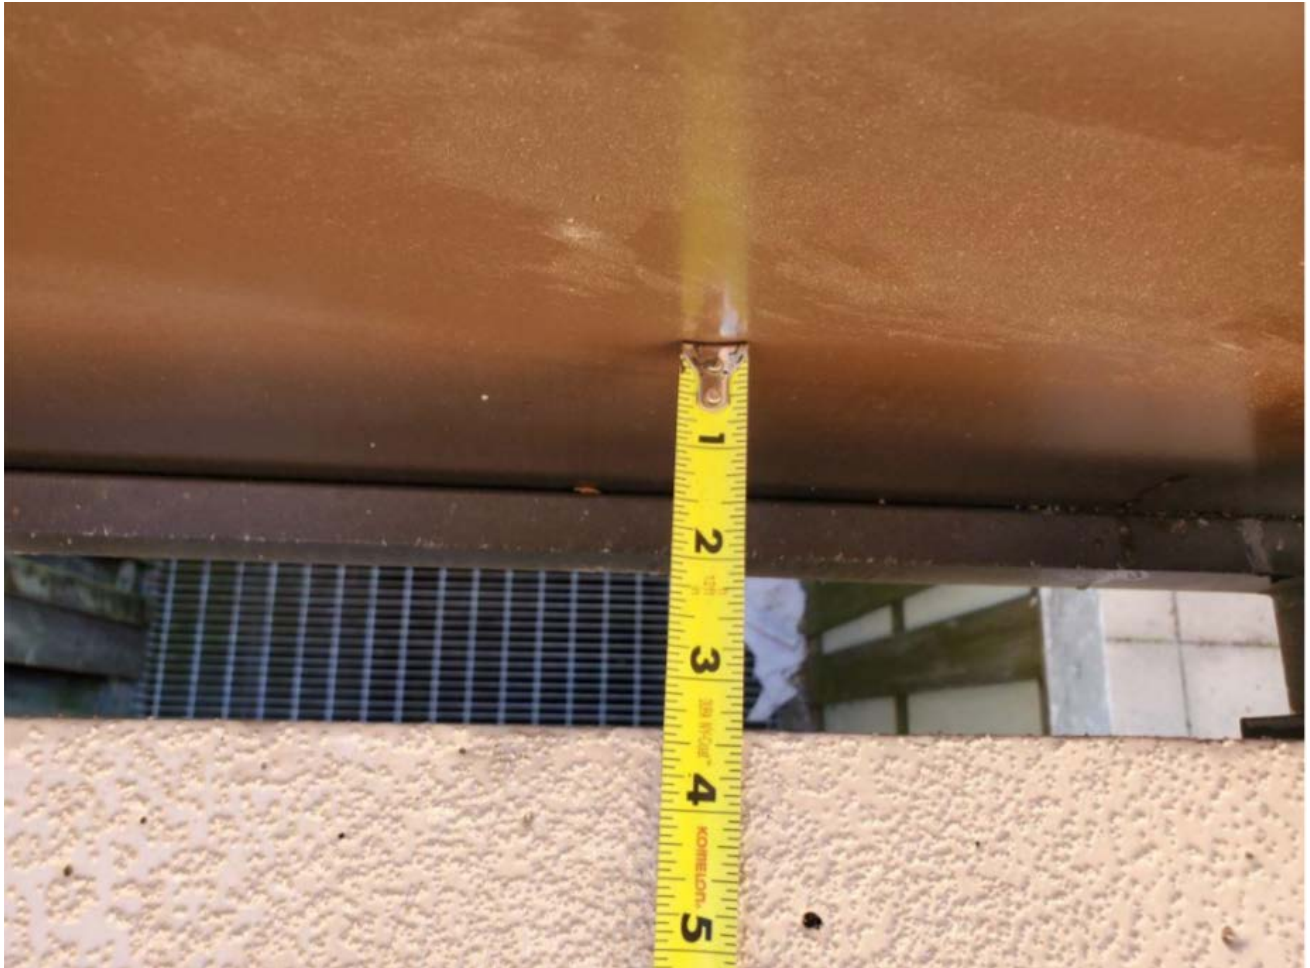
Image 2: The gap between the balcony slab and balcony guard rail that requires a closure plate per City of Toronto safety compliance measures.

Reason for change - Unforeseen site condition
